MVR Lock and Dam Section

Lock and Dam 11 Chain Failures

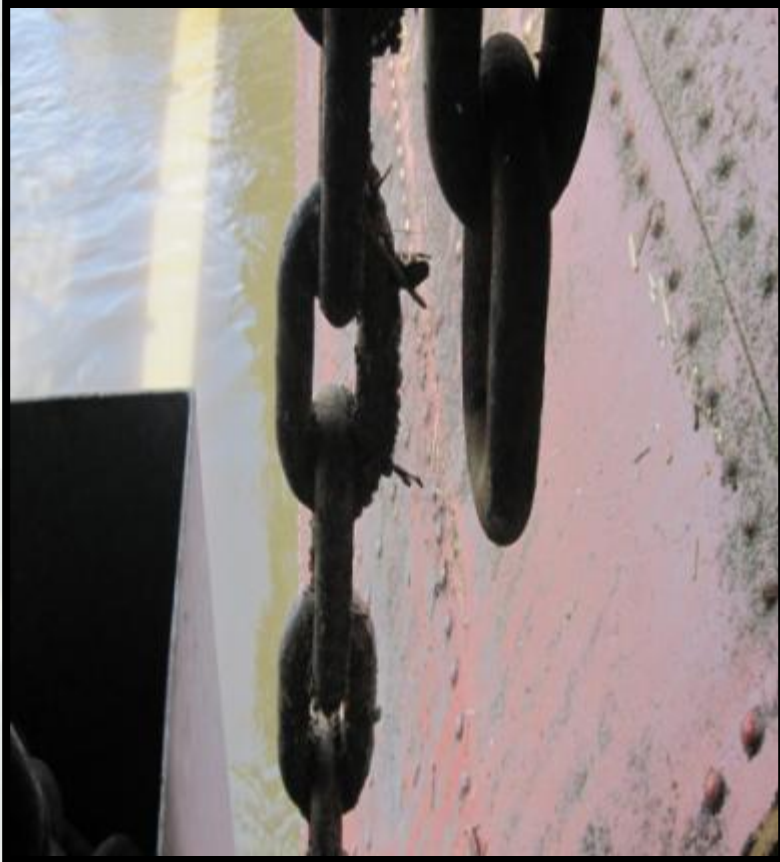
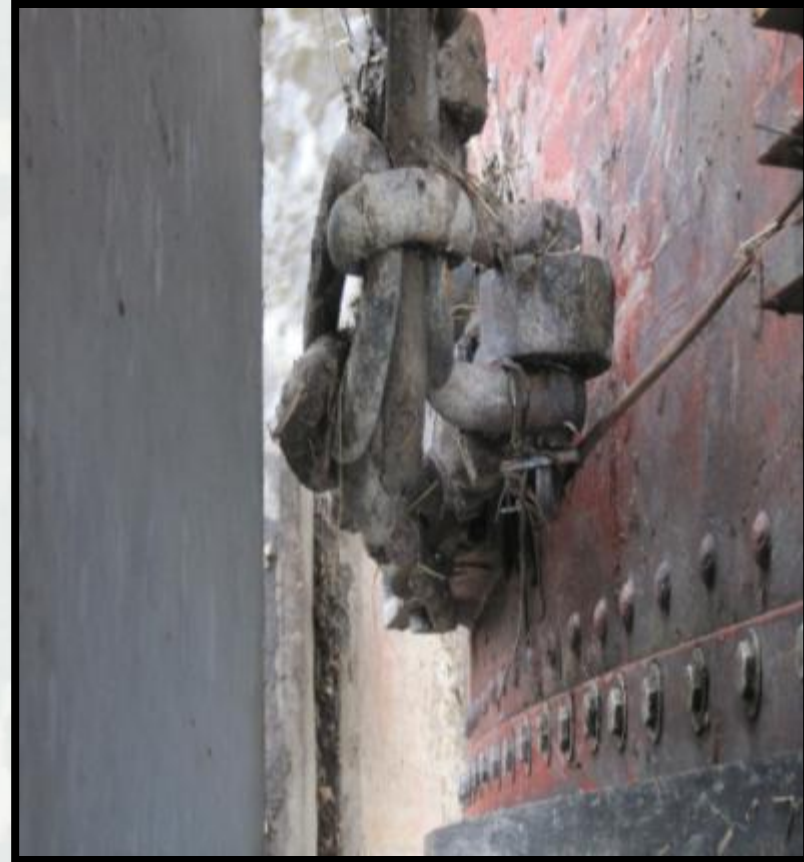
#3 TAINTER GATE

13th Link Missing

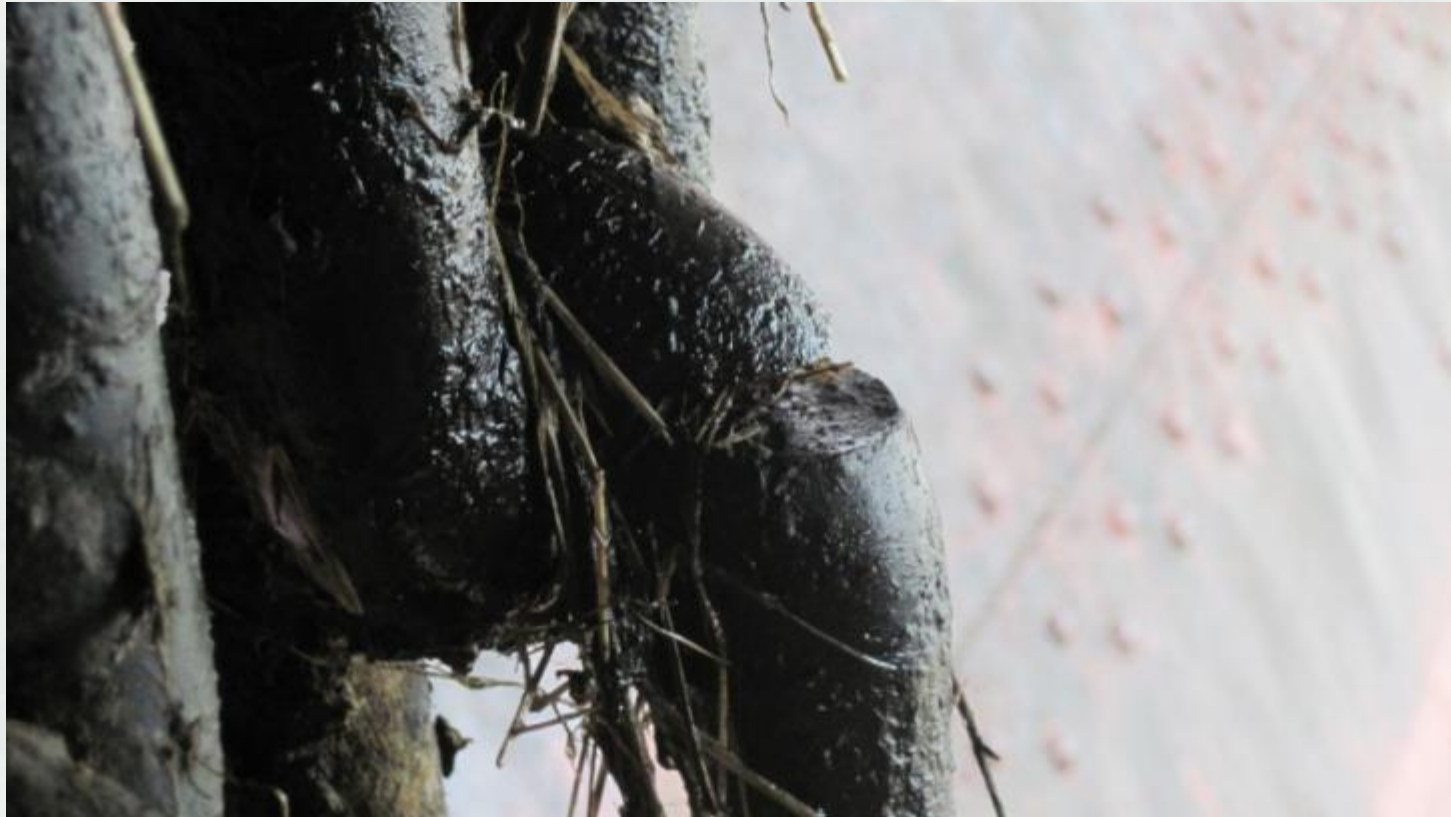
#5 TAINTER GATE

4TH Link Cracked

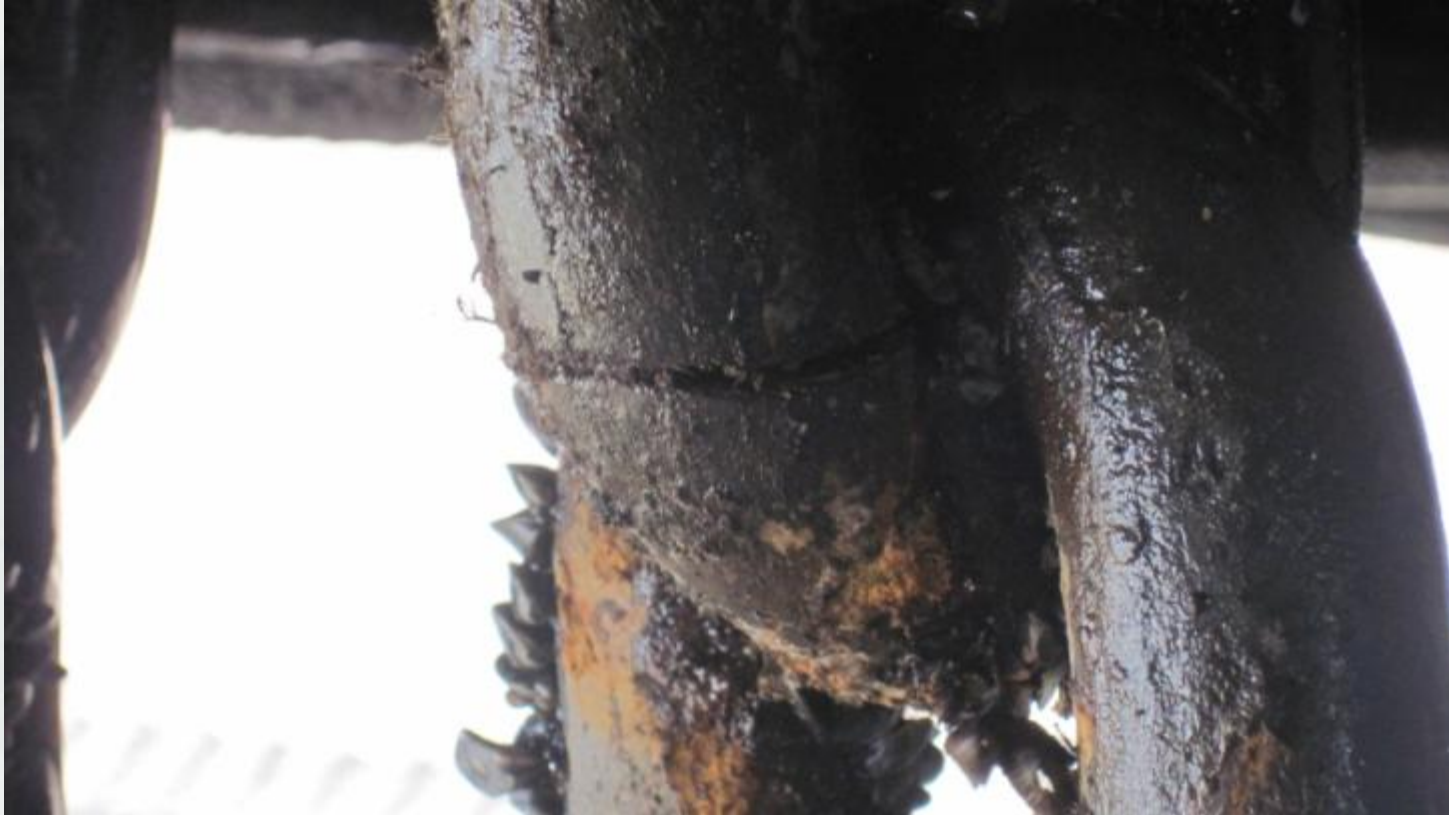
#11 TAINTER GATE

30TH Link Cracked

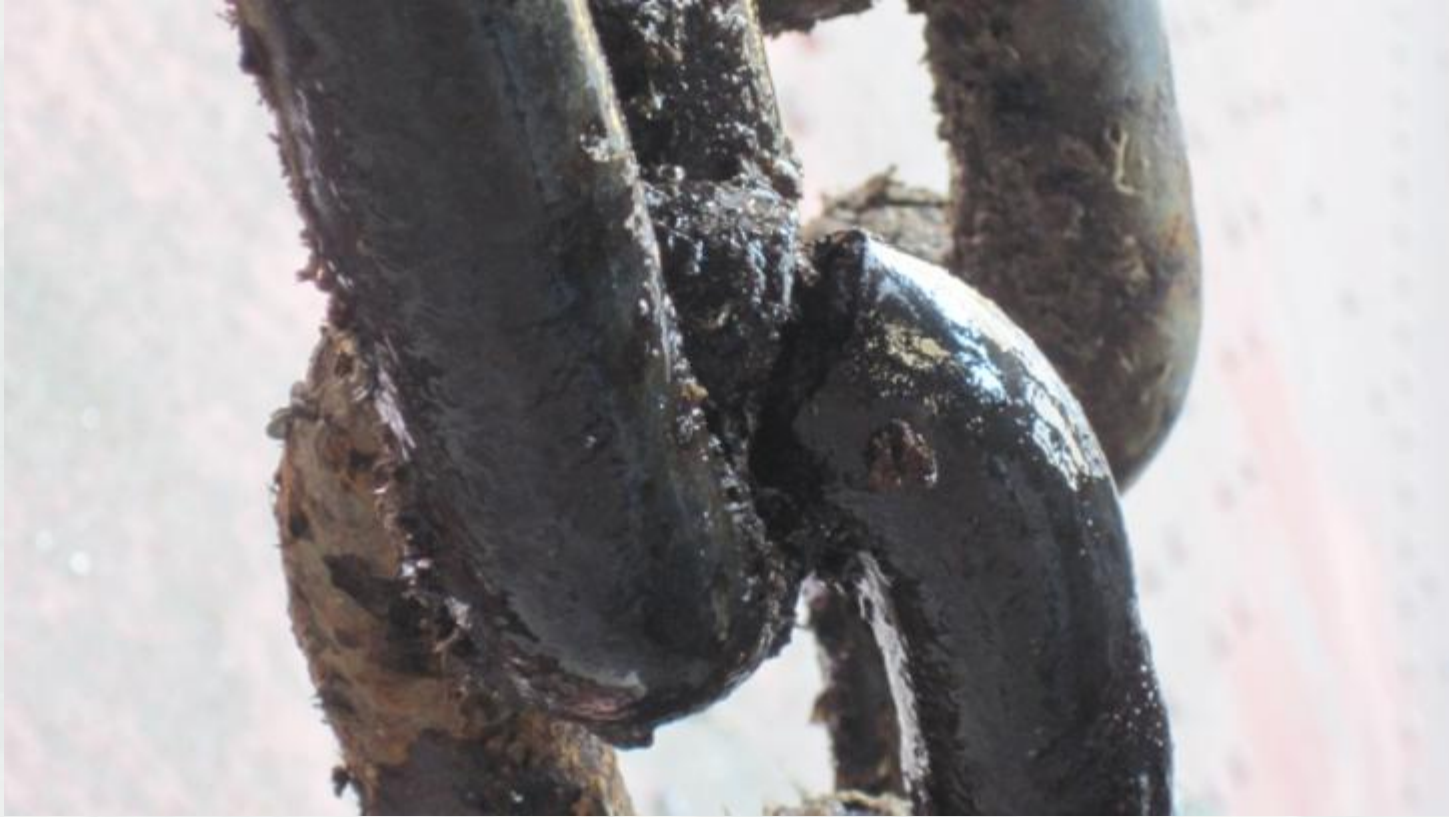
#12 TAINTER GATE

13th Link Cracked

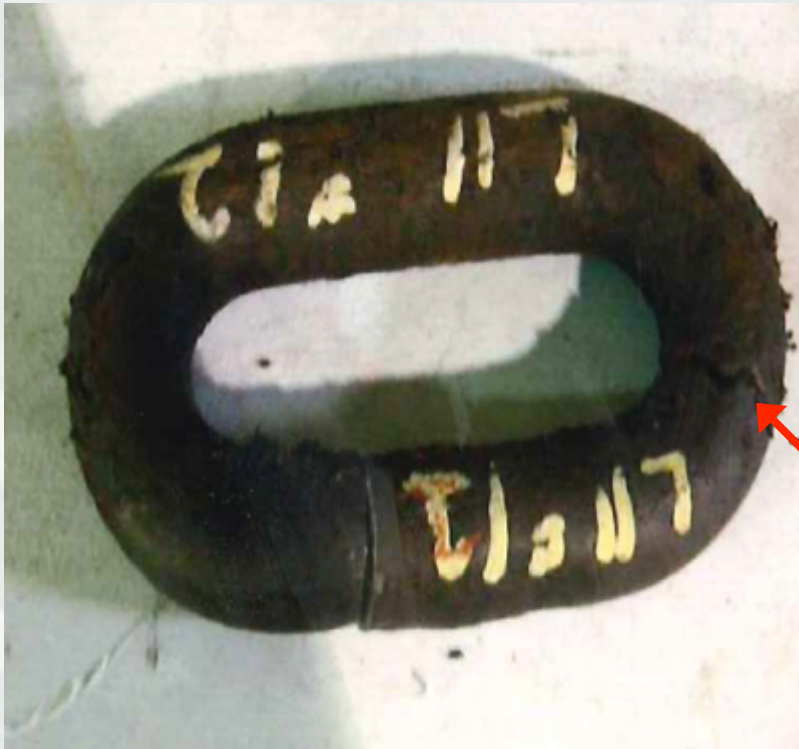
#12 TAINTER GATE

**FRACTURE
LOCATION**

- The fracture surfaces of the chains analyzed appeared to be ductile. Chain overload is the likely cause of failure. Tensile forces from overload conditions exceeded the strength of the links in approximately the same location for each of the links.
- The failure locations in each link are areas of heavy abrasion from adjoining links and the abrasion can produce higher stress concentrations at the inside surface of the chain.

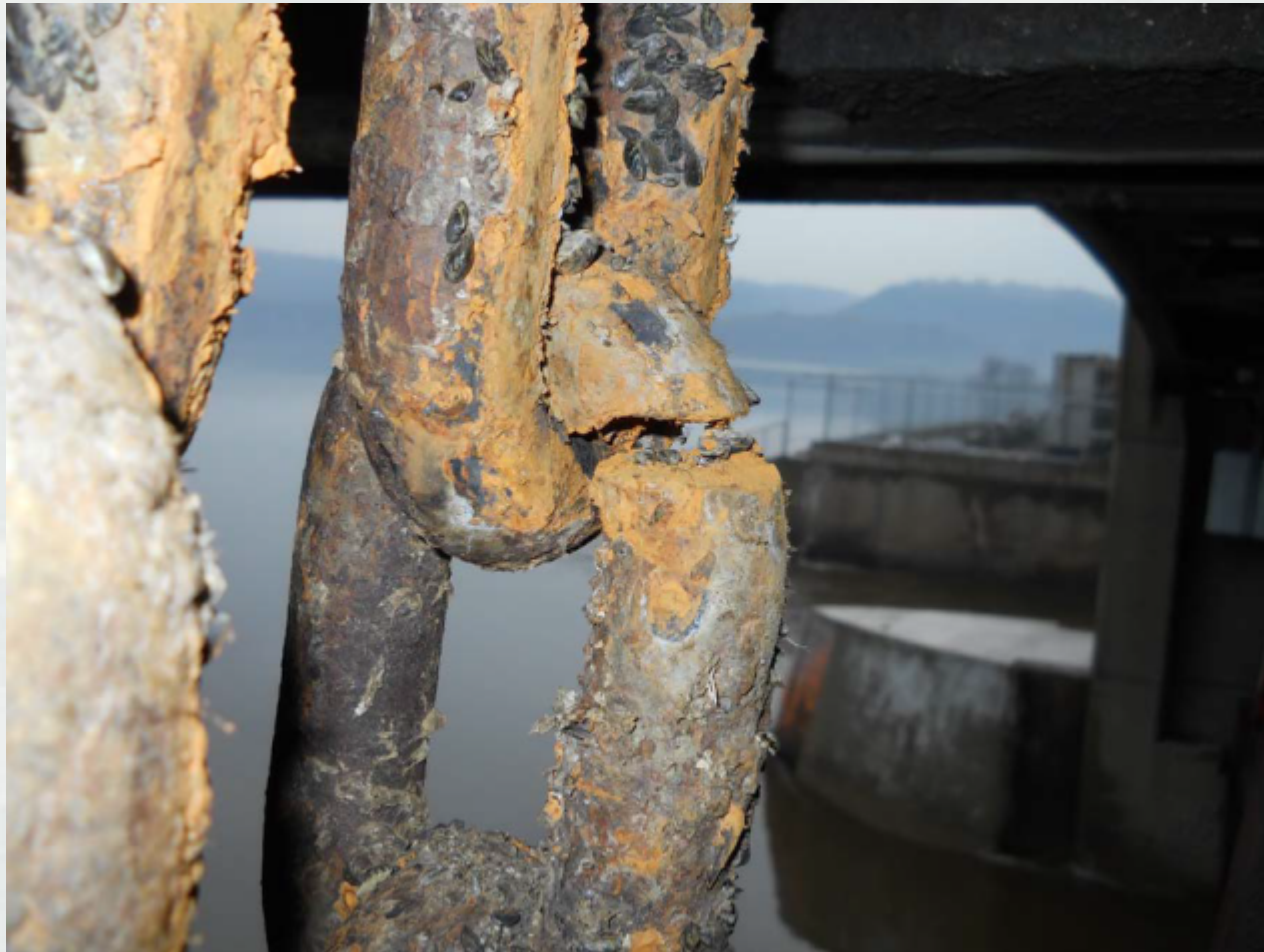
#15 TAINTER GATE

17TH Link Cracked

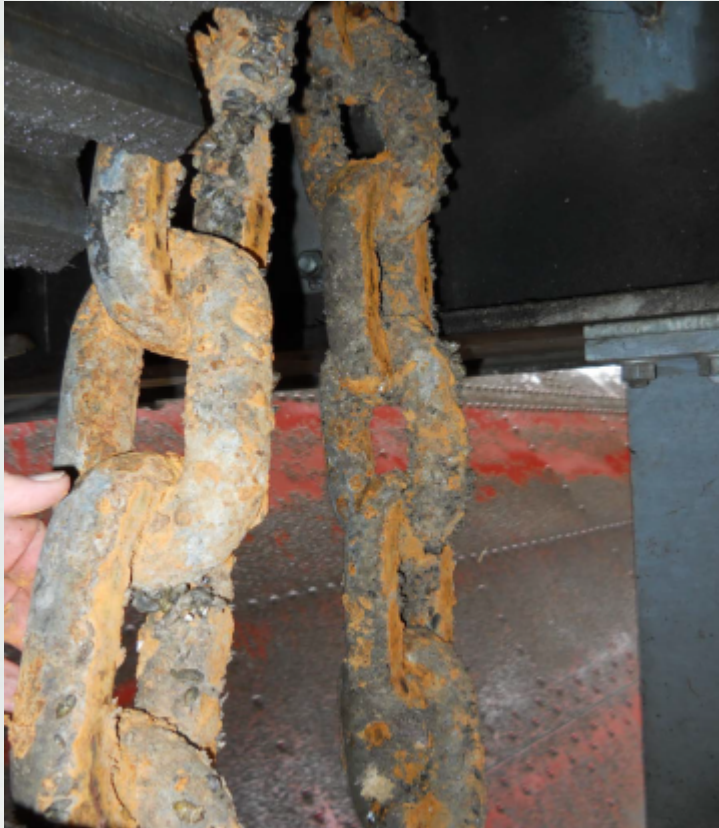
LD 11's

- The comparison of the chemical composition between the L/D 11 failed chain links and the L/D 11&12 spare chain links were of the same grade of material when compared to each other.
- Brinell hardness values for all chain link samples exceeded the original installation specification requirement of 340 BHN.
